## Dairy Waste Storage Tank Refurbishment

**Timely refurbishment can save 80%  
of tank replacement costs**

**Formatank Ltd delivered huge savings through the refurbishment of two 20 year old steel storage tanks at First Milk's Aspatria Facility in rural Cumbria.**

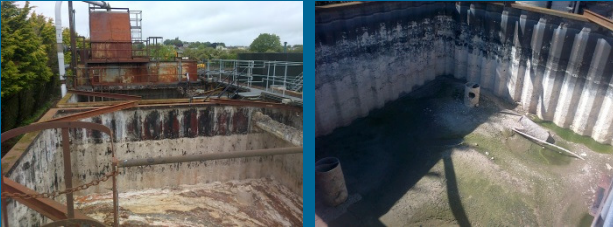
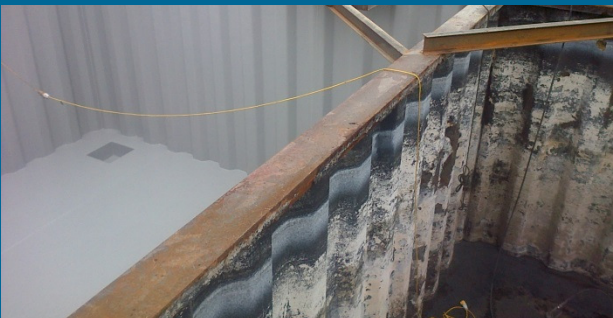
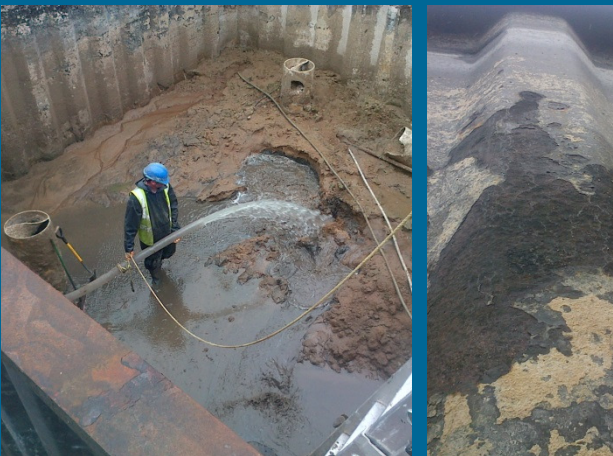
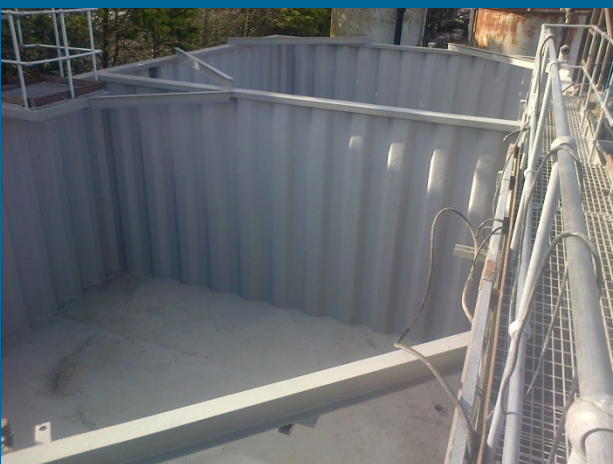
Formatank conducted a thorough cleaning process to remove the debris and derogation built up on the internal tank walls over the two decades of use operation. An in depth assessment is crucial to ensure structural and sanitary integrity. Performing Ultra-sonic tests of the tank wall thickness is crucial to determine the necessary course of action for refurbishment.

Although large areas of the tank wall were heavily corroded, the tanks were in suitable condition structurally for Formatank's skilled team to apply the 2-coat GRP liner to all tank walls and floors using a spray deposit technique to a thickness of 3mm. The GRP liner laminates the existing tank wall providing a fresh and safe internal tank coating which can be back to full operation 48 hours after application.
